Name Of Dam: TALBOTT DAM

Inventory Number: VA 14101

PHASE I INSPECTION REPORT

NATIONAL DAM SAFETY PROGRAM

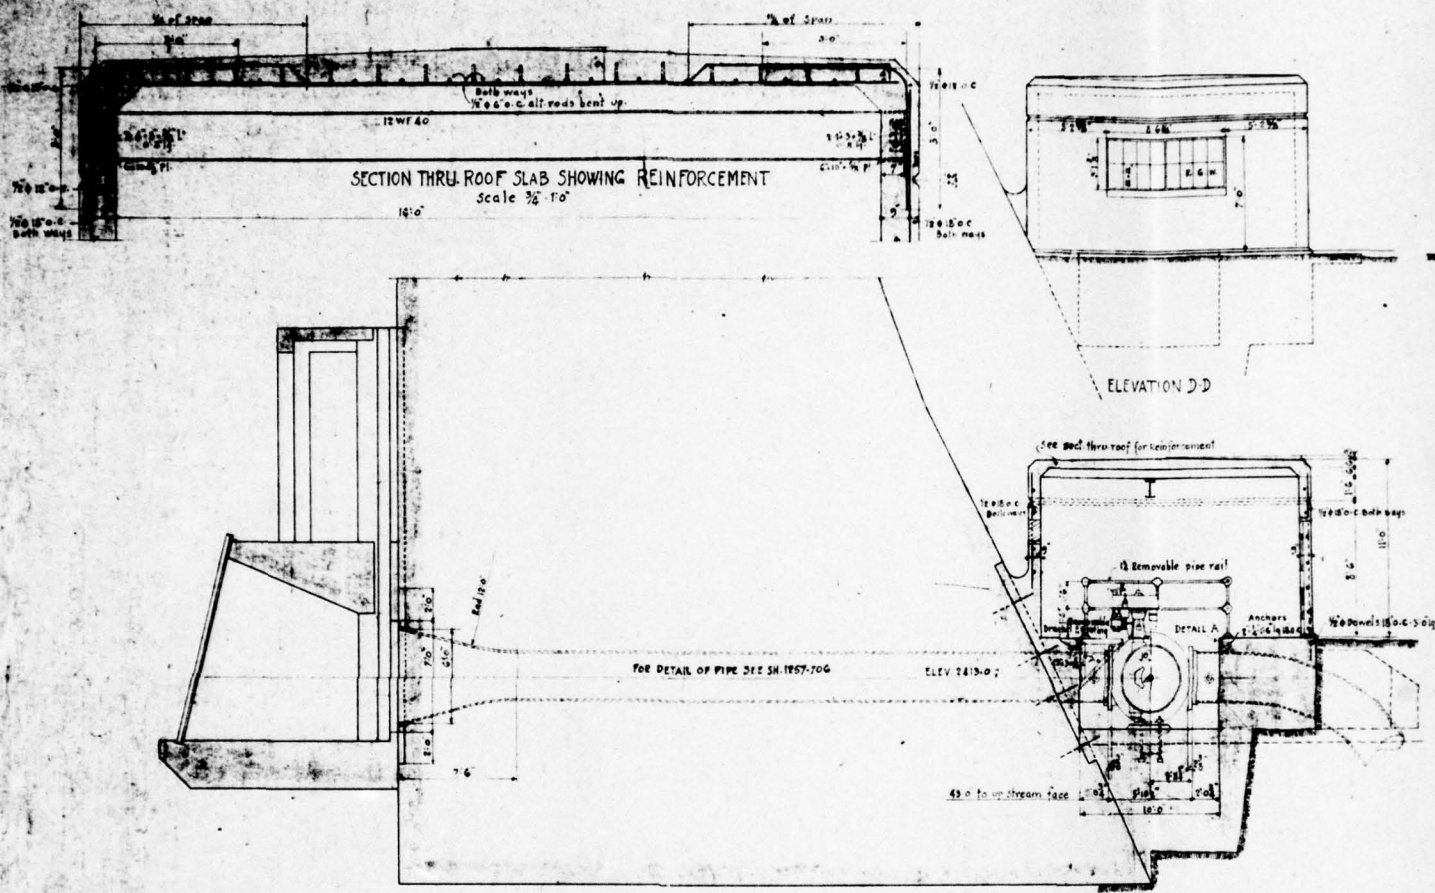
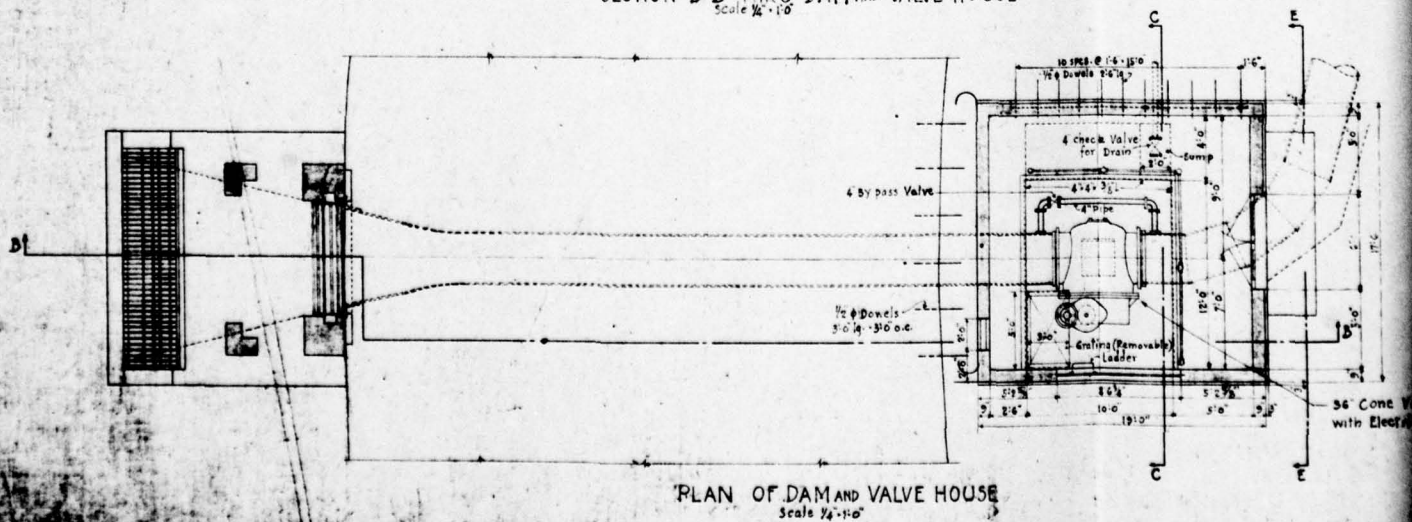
SECTION B-B THRU DAM AND VALVE HOUSE
Scale $\frac{1}{4}" = 1'-0"$

1. 6" Valves & Piping were found in lieu of 4" shown.
2. Two 36" inch Tandem Butterfly Valves were found in lieu of one 36" inch valve as shown.

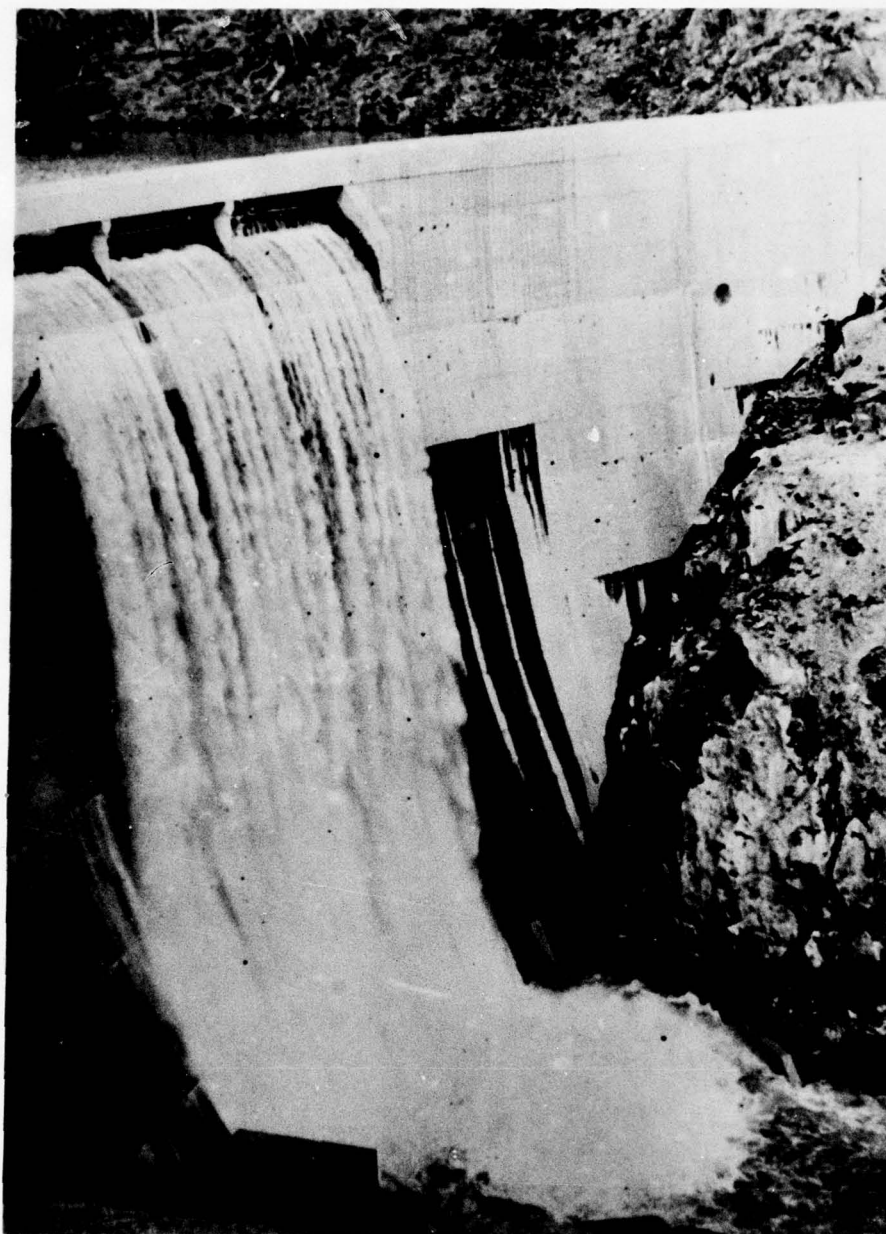
PHOTO 1

TALBOTT DAM---PHOTO PRIOR TO 1940
NOTE SEEPS THROUGH DAM
